Service Bulletin Number: CSP SB 20-20

Subject: New Diesel Particulate Filter Pressure Differential Sensor

Product Affected: X15e6 CM2350

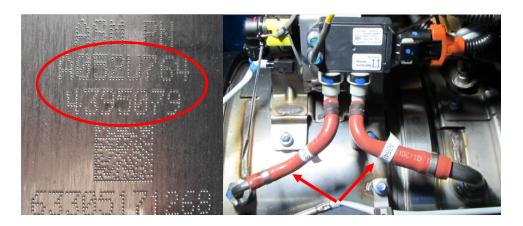
New sensor part number 5492073 has larger diameter tubes to reduce condensation build up and as such also requires the installation of larger diameter tubes.

If the old differential pressure sensor (part number 2871960) is diagnosed to be failed, the replacement new sensor (part number 5492073) should be installed.
